California State Board of Equalization
450 N Street, Sacramento, California

Mold Remediation – 8th Floor
Closure Report Addendum
Project No. 2372.02-572

Closure Report Date: August 17, 2010

Addendum Date: October 31, 2012

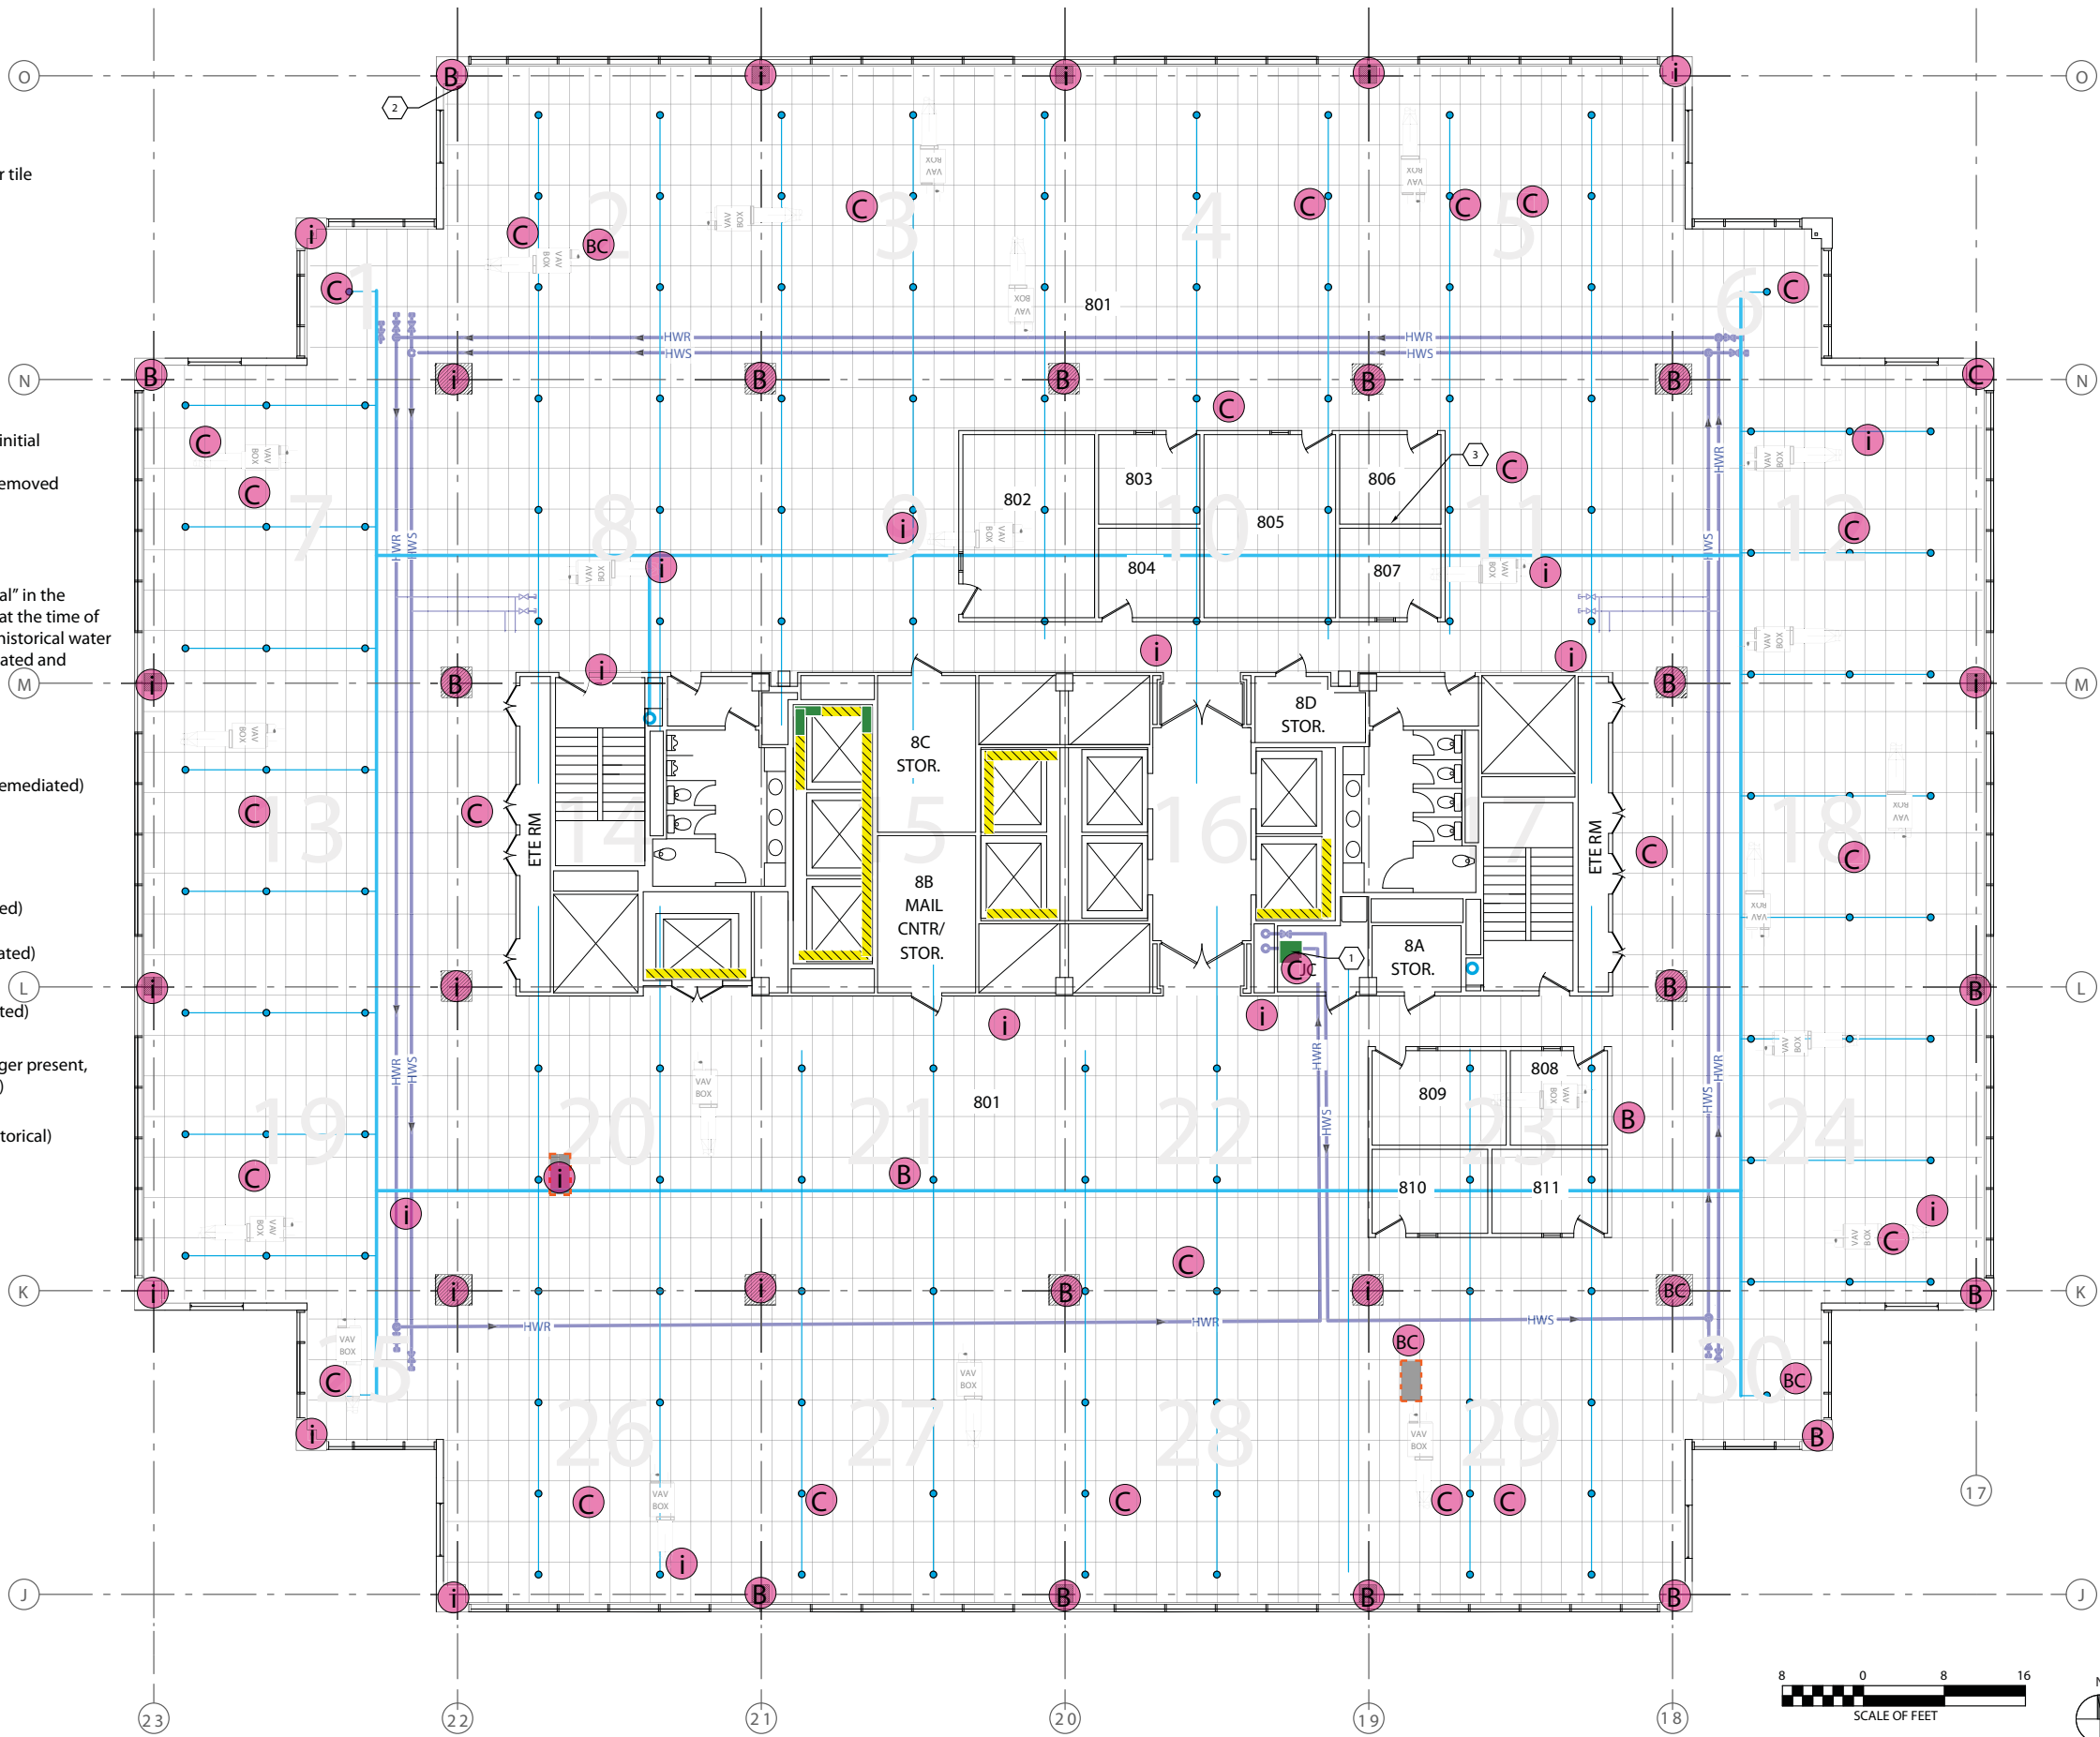
Figure 1

- 1 Visible mold growth 2 sq. ft. on ceiling
- 2 Rust stain on carpet
- 3 Water under sink, loosened floor tile
